**TRANSPORTATION RESEARCH CENTER**

**ON-SITE AIR BAG INVESTIGATION**

CASE NO. - 90-01  
FLEET - PRIVATE VEHICLE  
LOCATION - [REDACTED] INDIANA  
ACCIDENT DATE - [REDACTED] 1990

TRC/IU CASE NO. 90-01

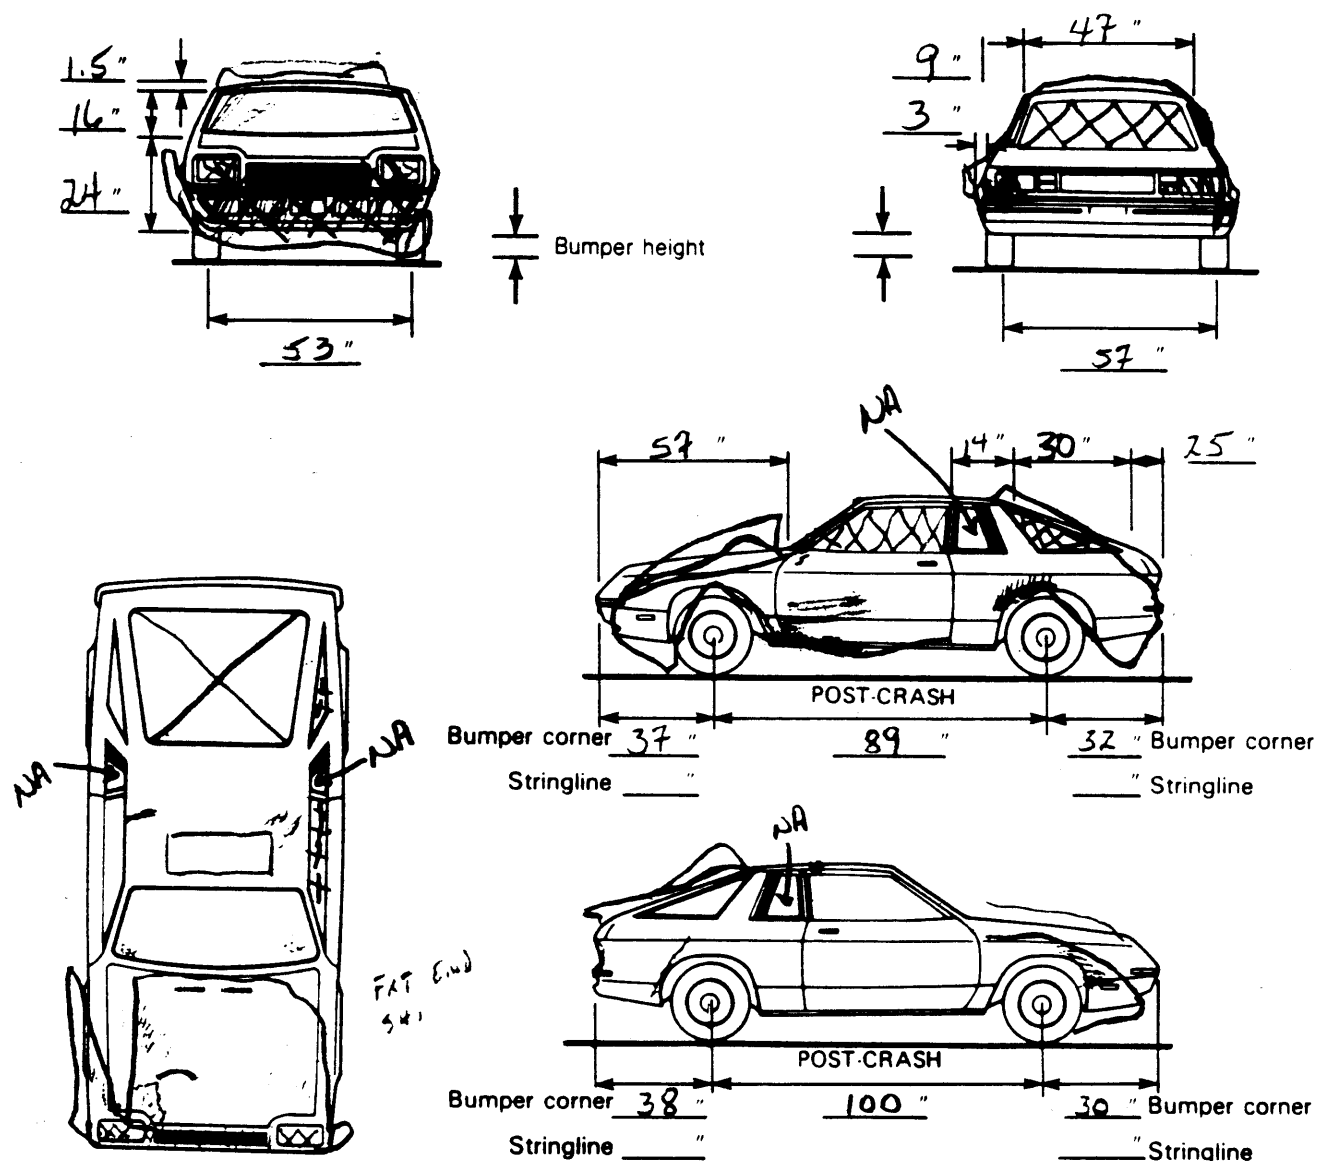
## VEHICLE DAMAGE SKETCH

Specific Impact No.	Location of Direct Damage	Location of Field L	Location of Maximum Crush
1	UNDERCARRIAGE	DAMAGE MASKED BY SPECIFIC IMPACT # 2	
2	FRONT	FRONT BUMPER	C <sub>1</sub>
3	REAR	REAR BUMPER	C <sub>1</sub>

<b>TIRE - WHEEL DAMAGE</b> a. Rotation physically restricted RF <u>2</u> LF <u>1</u> RR <u>2</u> LR <u>2</u> (1) Yes (2) No (8) NA (9) Unk.		<b>b. Tire deflated</b> RF <u>1</u> LF <u>1</u> RR <u>2</u> LR <u>2</u>		<b>ORIGINAL SPECIFICATIONS</b> Wheelbase <u>100.5</u> Overall Length <u>179.6</u> Maximum Width <u>68.3</u> Curb Weight <u>2759</u> Average Track <u>56.8</u> Front Overhang <u>40.5</u> Rear Overhang <u>39.8</u> Engine Size: cyl./ displ. <u>5.0L V8 HO, EFI</u> Undeformed End Width <u>59</u>		<b>WHEEL STEER ANGLES</b> (For locked front wheels or displaced rear axles only) RF $\pm$ <u>0</u> <u>0</u> ° LF $\pm$ <u>0</u> <u>0</u> ° RR $\pm$ <u>0</u> <u>0</u> ° LR $\pm$ <u>0</u> <u>0</u> ° Within $\pm 5$ degrees	
<b>TYPE OF TRANSMISSION</b> <u>5 SPEED</u> <input checked="" type="checkbox"/> Manual <input type="checkbox"/> Automatic				<b>DRIVE WHEELS</b> <input type="checkbox"/> FWD <input checked="" type="checkbox"/> RWD <input type="checkbox"/> 4WD		Approximate Cargo Weight <u>          </u>

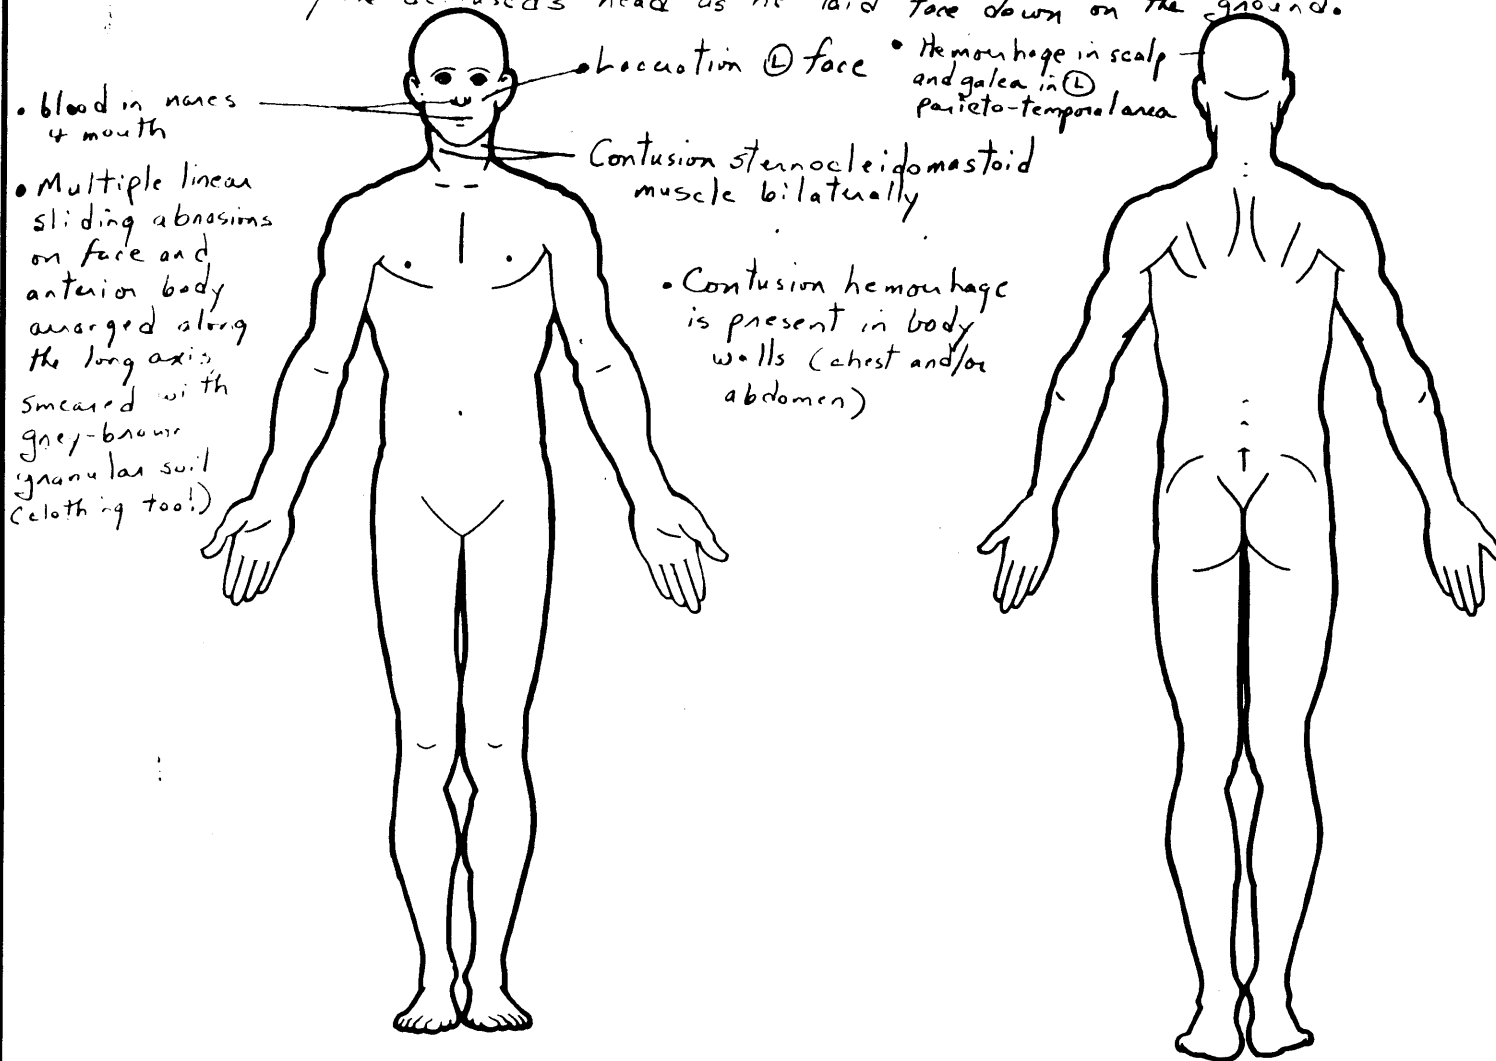
- Ejected through sun roof. Vehicle landed partially on top of body. The front bumper was at the back of the deceased's head as he laid face down on the ground.

Cause of Death: ... injury of head &amp; chest

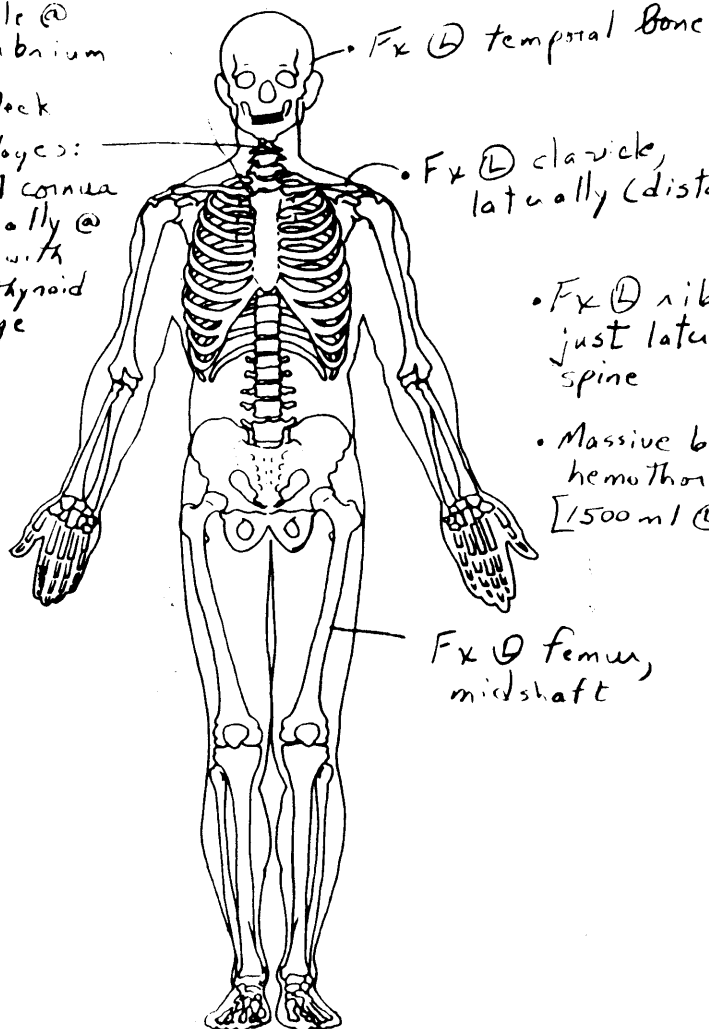
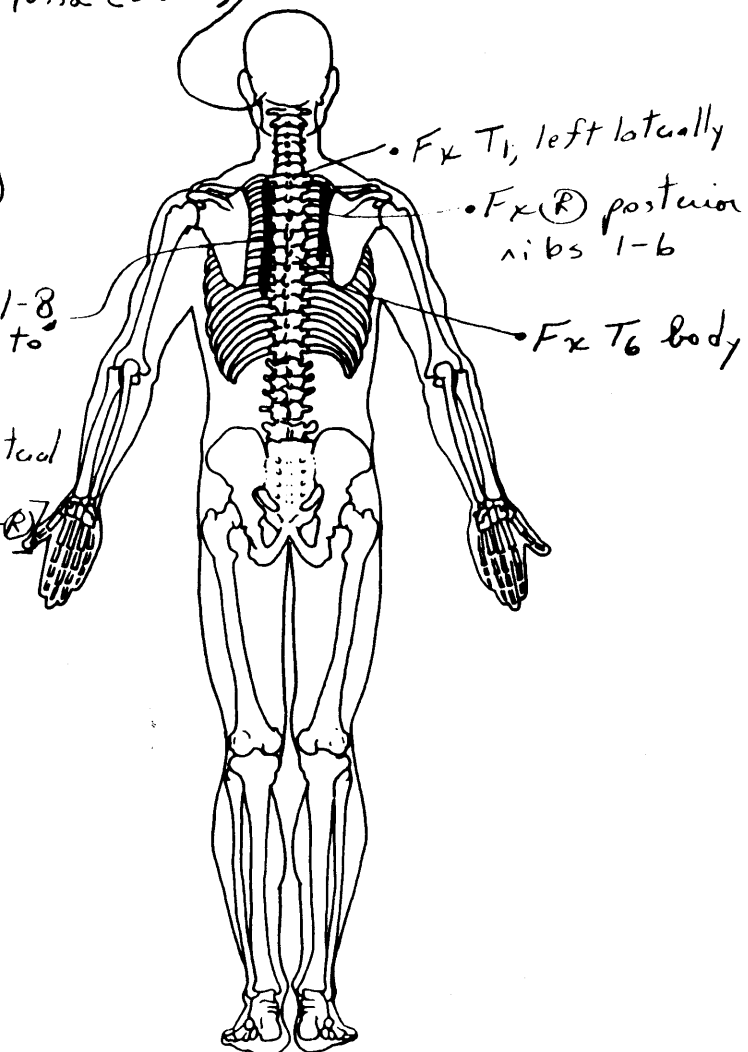
- Fx + dislocation (R)  
clavicle @  
manubrium

- Fx Neck  
Cartilages:  
thyroid cartilage  
bilaterally @  
corner with  
body of thyroid  
cartilage

- Fx (L) posterior  
fossa (basilar)

- Fx (L) ribs 1-8  
just lateral to  
spine

- Massive bilateral  
hemothorax  
[1500 ml (L) + (R)]
